Manhole Inspection Summary

Manhole # S23K__019MH

Insp Date: **6/10/08 8:18 AM**

Location Address: **349 S Stricker St**

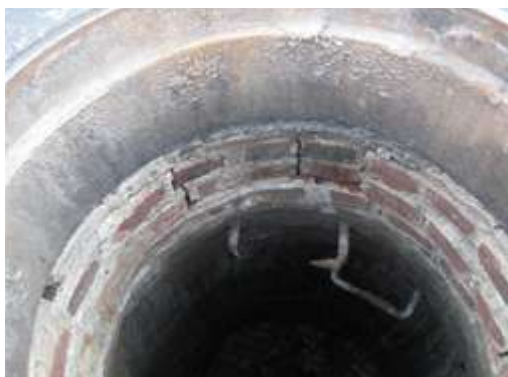
Defect 6

Frame Offset: **0** (in.) Condition: ☐ Sound ☐ Cracked ☒ **Leaks**

infiltration lid-frame

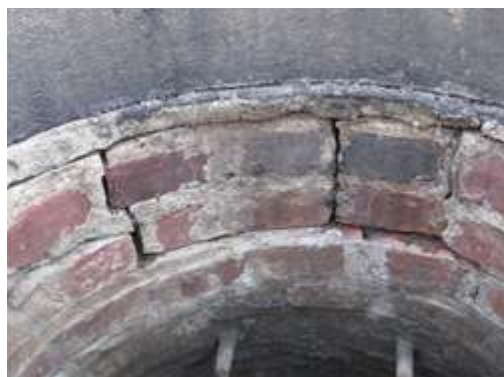
Defect 5

Condition: ☐ Sound ☒ **Cracked** ☐ Root Intrusion ☒ **Loose Brick** ☐ Deteriorated

loose , craked bricks

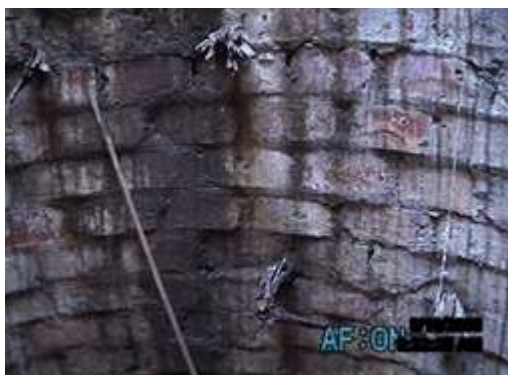
Defect 3

Infiltration: ☐ None ☐ Joint ☐ Cracks ☐ Mortar ☐ Roots ☒ **Wall**

missing rungs, barrel infiltration

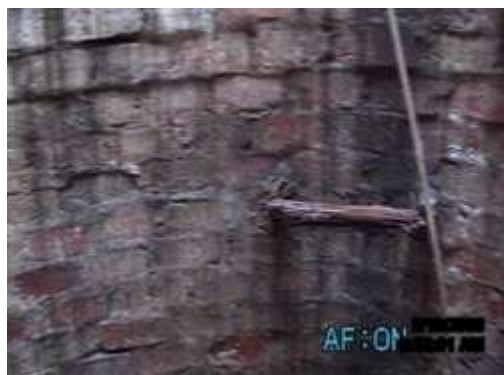
Defect 2

Steps Count: **6** Missing: **2** ☒ **Corroded**

corroded rungs

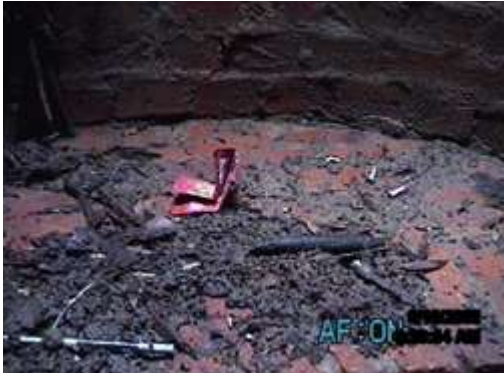
Defect 1

Condition: ☐ Sound ☐ Cracked ☐ Root Intrusion ☐ Deteriorated ☐ Leaks ☒ **Debris**

debris on bench

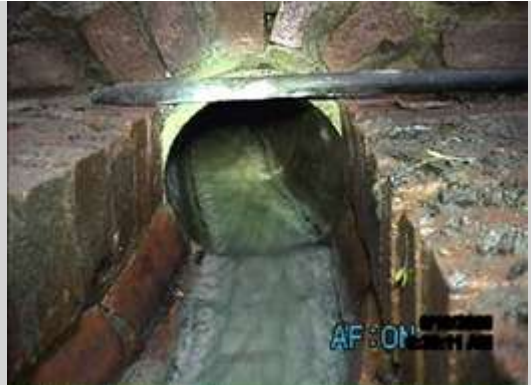
12 O'Clock Outflow

Pipe Height: **8.4** (in.) Rod and Bar (Angled)
Pipe Material: **Clay** ☐ Pipe Lined
Invert Depth: **10.02** (ft.) Flow Characteristics: **Fast**
Deposits: ☒ None ☐ Mud ☐ Sludge ☐ Debris ☐ Grease
Silt Depth: **0** (in.) Deposits Extent:
Infiltration: **None** Pipe Seal Cond: **Sound**

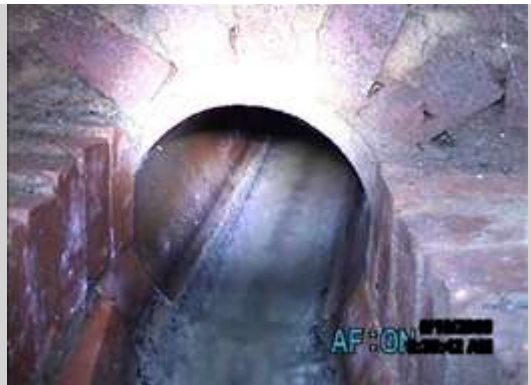
7 O'Clock Inflow

Pipe Height: **8.4** (in.) Rod and Bar (Angled)
Pipe Material: **Clay** ☐ Pipe Lined
Invert Depth: **9.97** (ft.) Flow Characteristics: **Fast**
Deposits: ☒ None ☐ Mud ☐ Sludge ☐ Debris ☐ Grease
Silt Depth: **0** (in.) Deposits Extent:
Infiltration: **None** Pipe Seal Cond: **Sound**
